Parcel C Remedial Action

Project Update for Parcel C Hunters Point Naval Shipyard San Francisco, California

BCT Meeting August 29, 2013

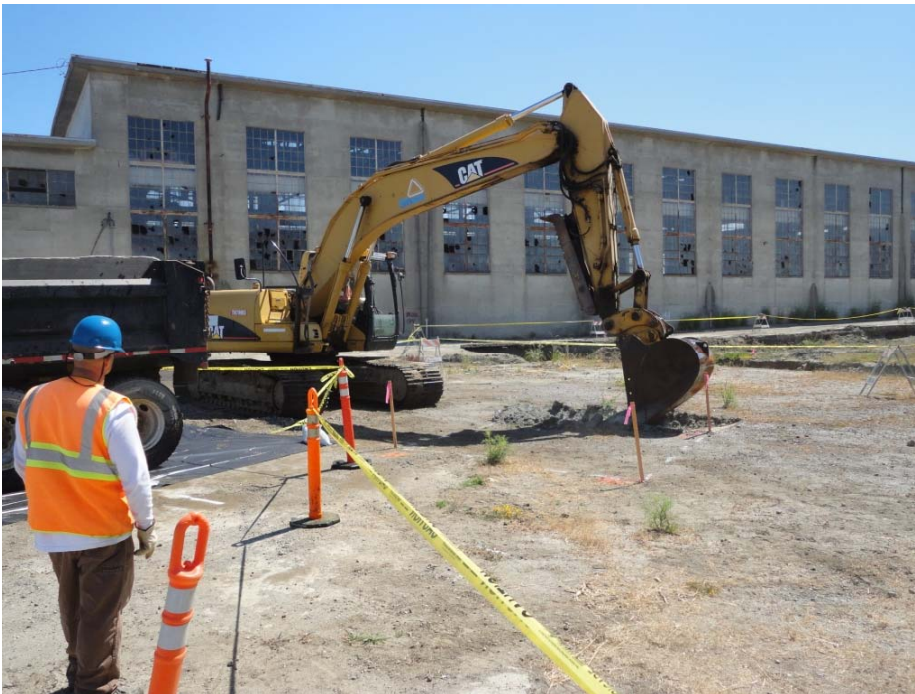
First bucket of soil removed in Excavation 10-3 (Bldg 134 in background) on 7/18 facing northeast

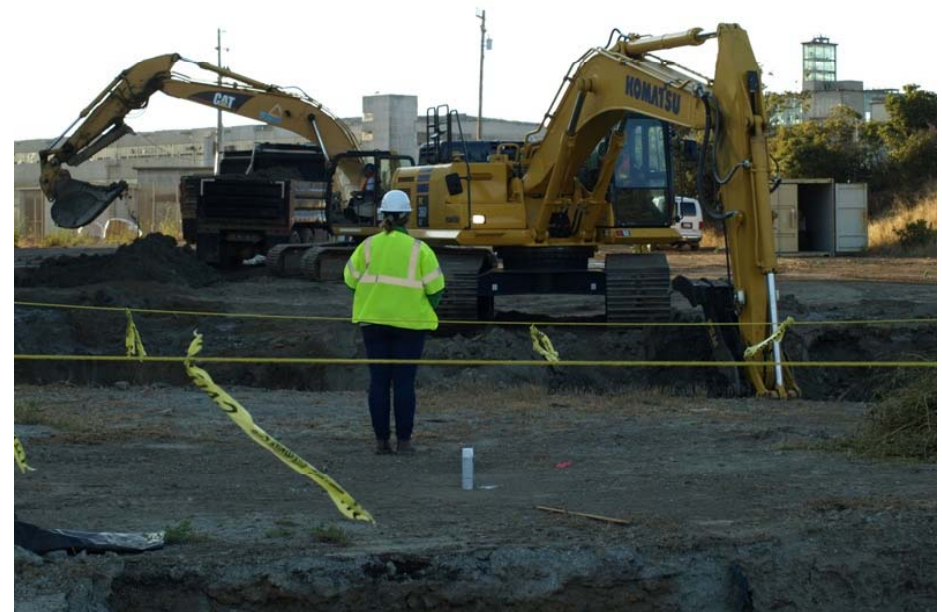
Excavating 10-3 (foreground) and loading of excavated soil (background) facing southeast on 7/24

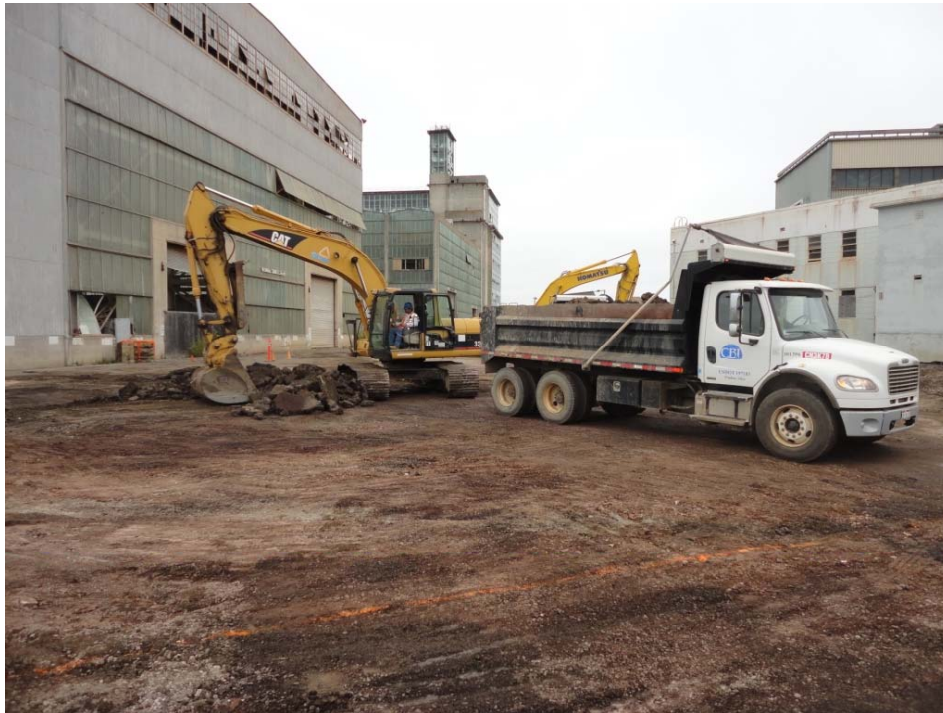
Asphalt removal in Excavation 22-1 area next to Bldg 231 facing southeast on 8/5

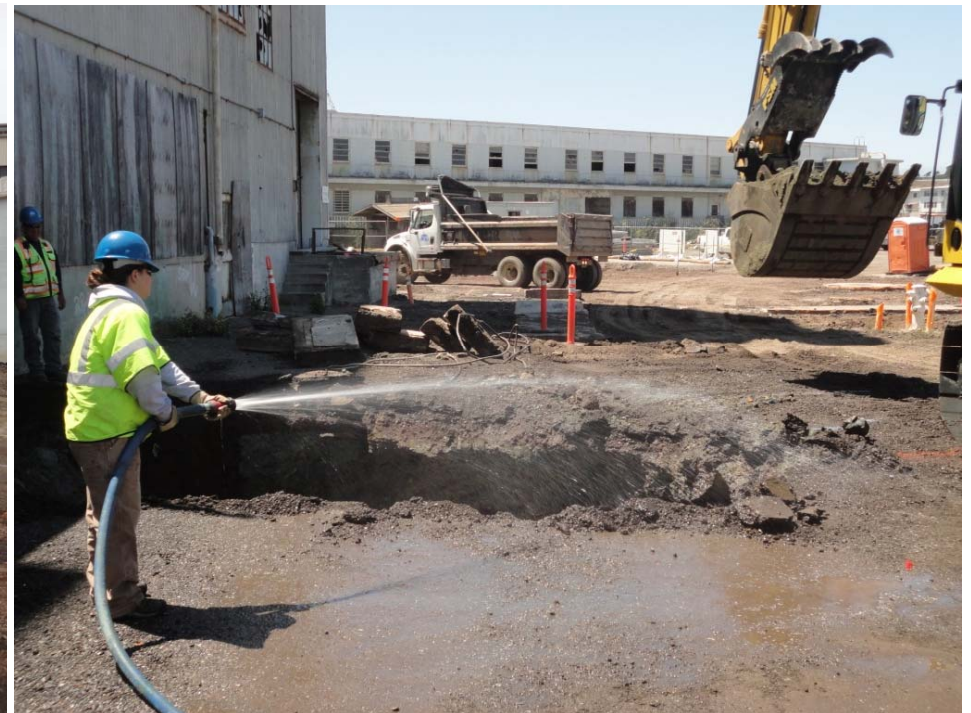
Excavation and dust control in Excavation 22-1 on 8/12

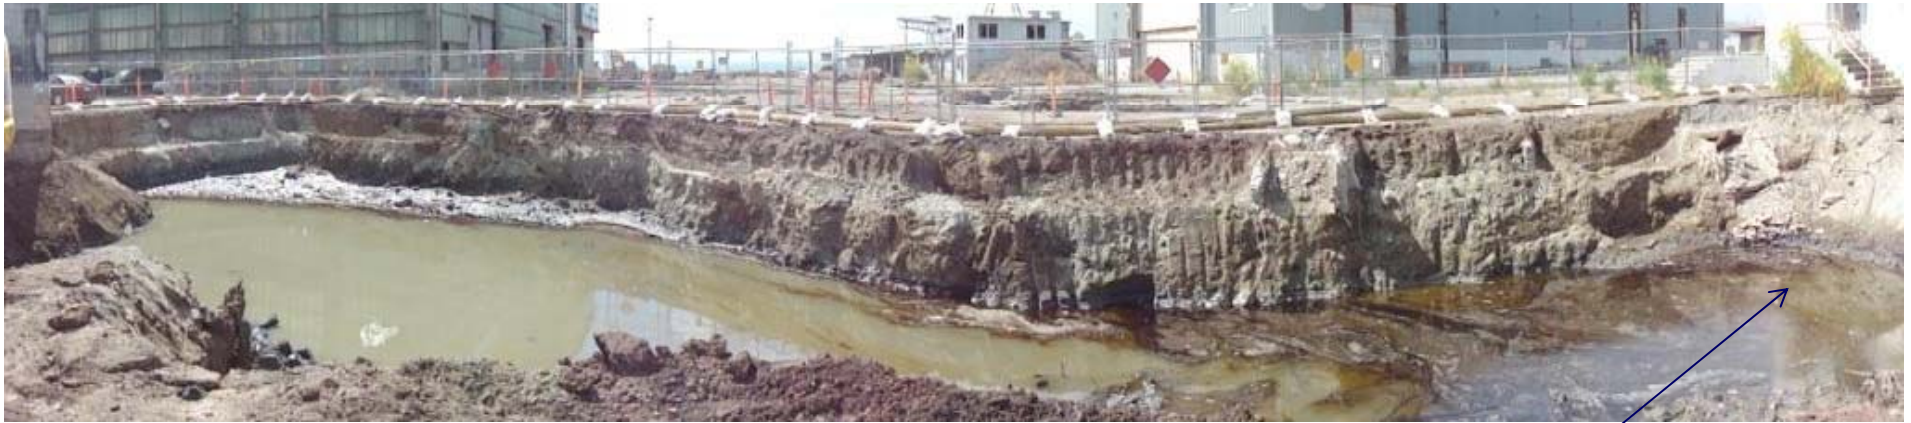
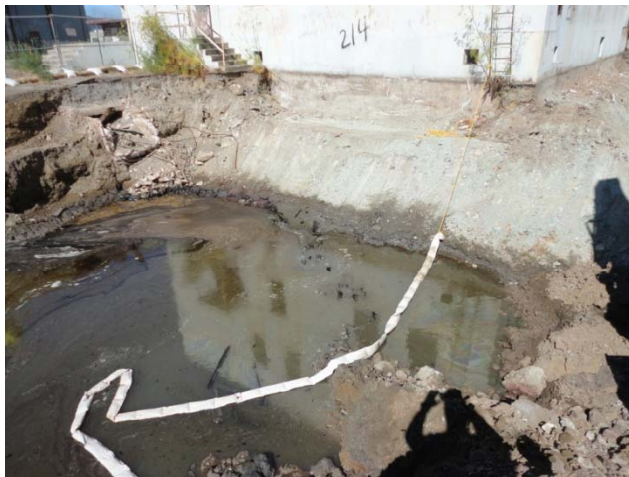
Excavating RU-C1 (22-1) - TPH Encountered

Close-up of Bldg 214 corner –
Deploying oil boom to absorb TPH in
Excavation 22-1 (8/16)

- TPH at corner of Bldg 214 at 10 ft bgs, facing southeast
- Corresponds to TPH Program's AOC 28-J
- Over-excavation planned to address TPH

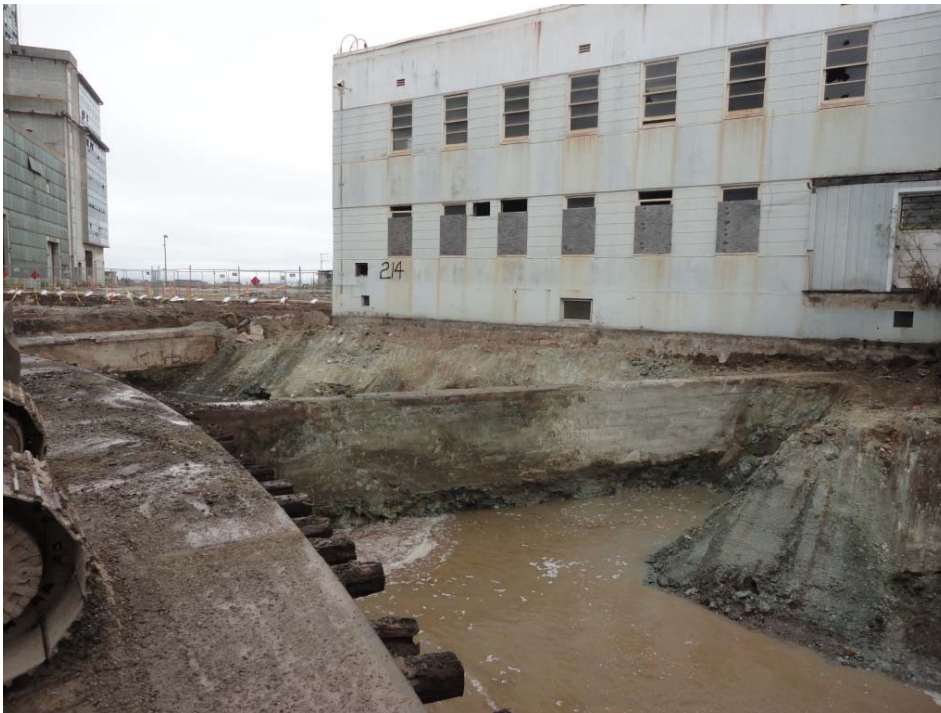
Encountered old seawall when excavating
Excavation 22-1 next to Bldg 214 (8/6)

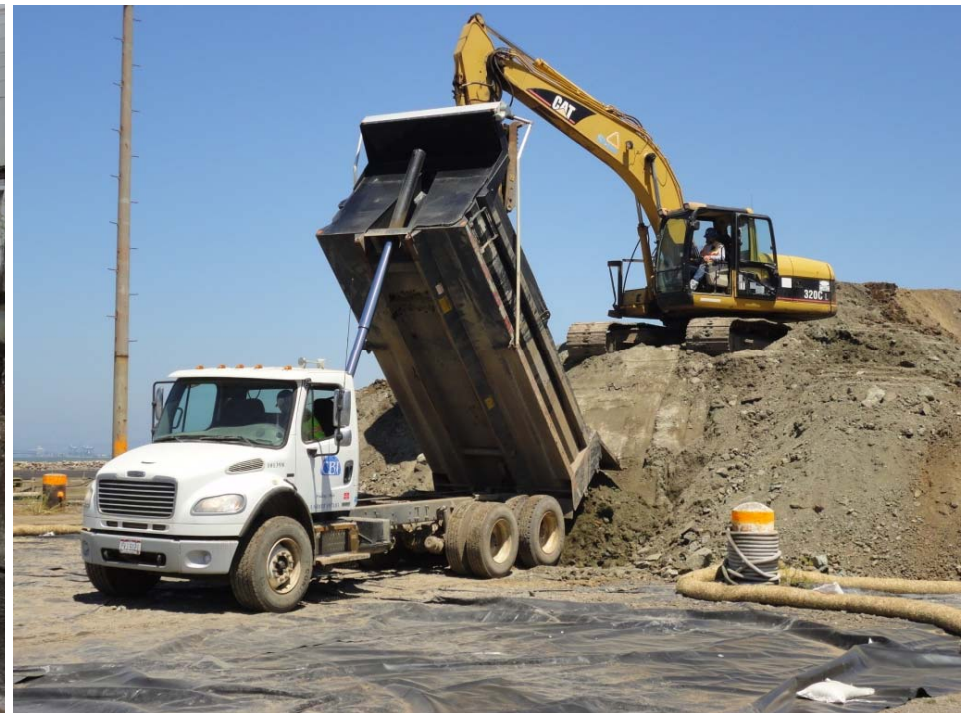
Stockpiling RU-C1 tall to maximize soil
storage space along Bldg 231

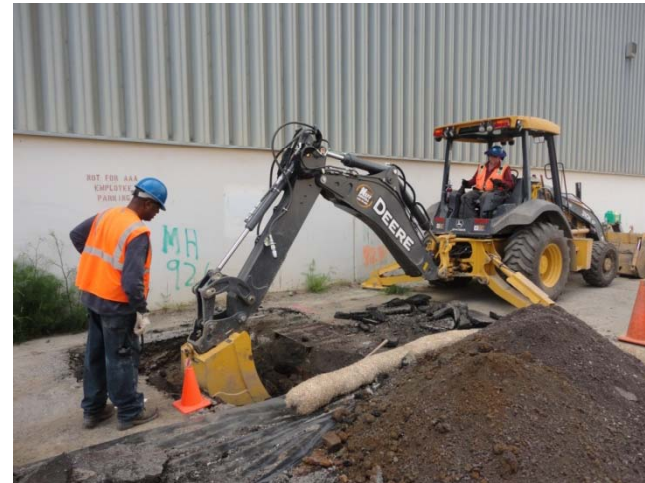
- When piping (1-1/2 inch diameter approx 125 lf long) was exposed, the solvent line was triple rinsed
- Line was pressure tested twice
 - held 8 PSI for over 30 minutes without pressure drop
- Line will be grouted

Exposing Solvent Line

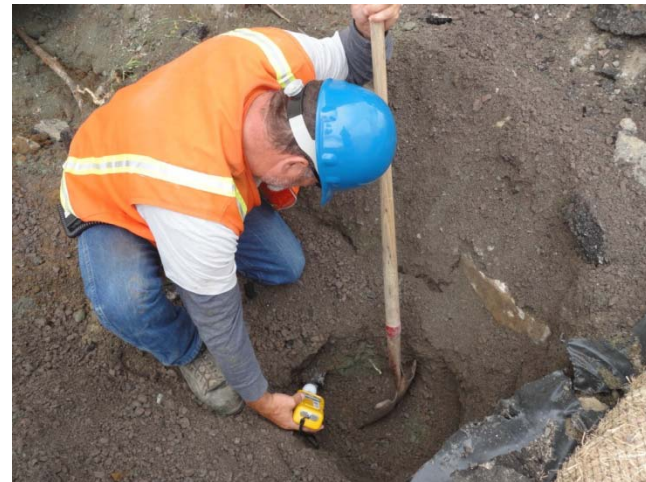
Checking conditions with PID while approaching solvent line (8/15)

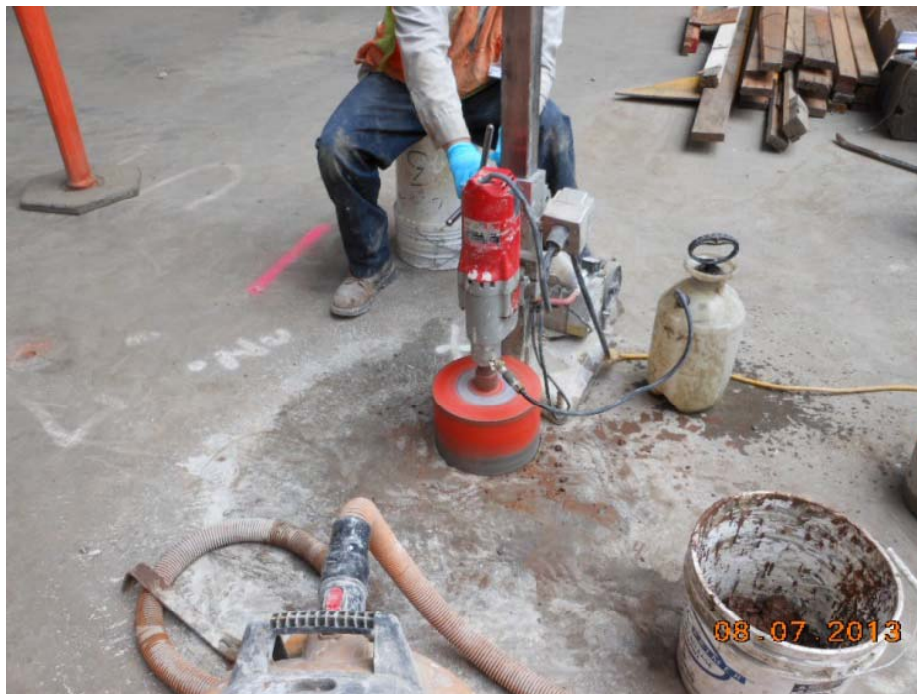
Concrete coring and installation of 11 soil vapor monitoring points in Bldg 253 – cored through concrete up to 30" thick (8/7)

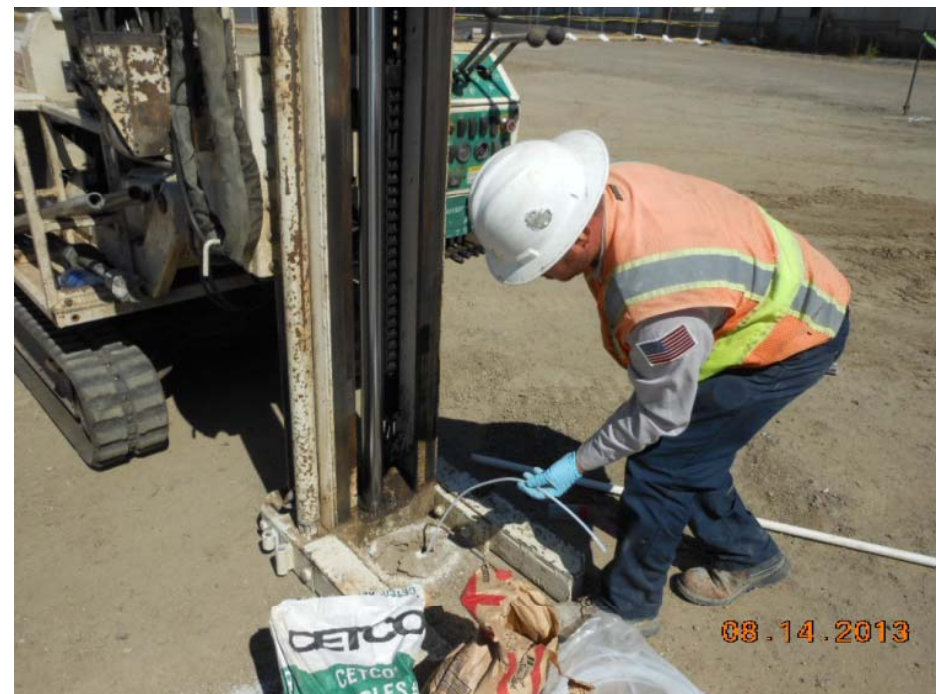
Installing soil vapor monitoring point (9 total) in RU -C1 (SVE Area 3 on 8/14)
